# Manhole Inspection Summary

Manhole # S43U\_\_014MH

Record Plat: **43U** Node: **014** Status: **New Manhole (Not in GIS)** Insp Date: **9/8/09 12:00 AM**

**Location** Address: **1327 Lowman St.**

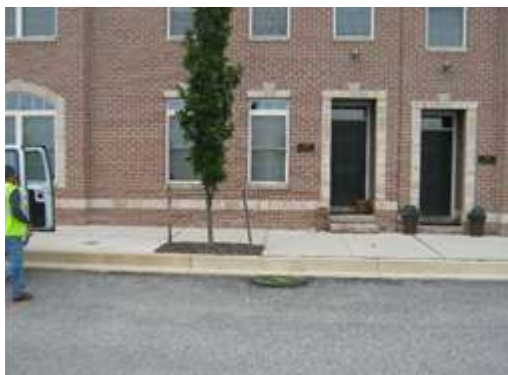
Location View

View east

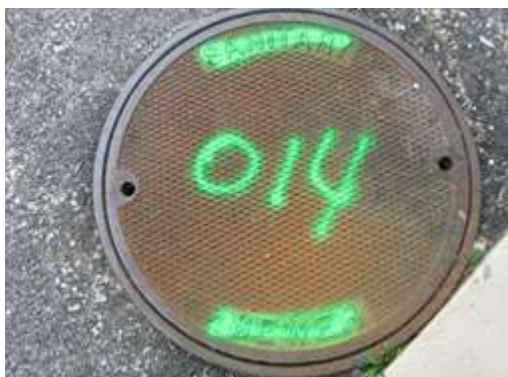
Miscellaneous

Comments **Lid is too small for the frame, and road hasnt gotten its final layer of asphalt.**

MH Lid

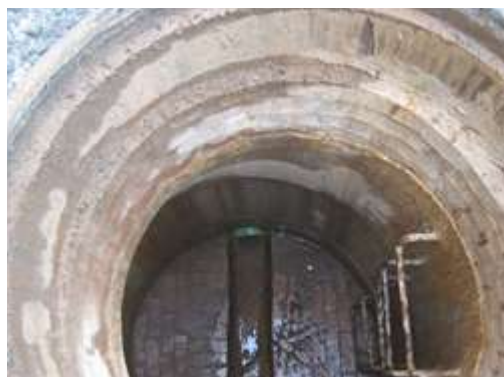
Defect 4

Infiltration: ☐ None ☒ **Joint** ☐ Cracks ☐ Mortar ☐ Roots ☐ Wall

chimney frame joint infiltration

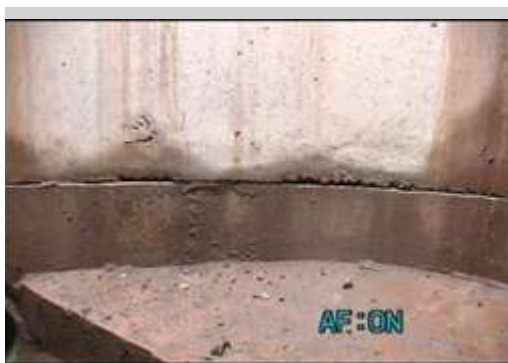
Defect 1

Infiltration: ☐ None ☒ **Joint** ☐ Cracks ☐ Mortar ☐ Roots ☐ Wall

barrel joint infiltration

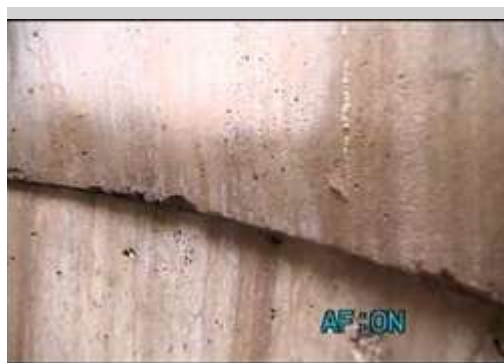
Defect 2

Infiltration: ☐ None ☒ **Joint** ☐ Cracks ☐ Mortar ☐ Roots ☐ Wall

evidence of corbel joint infiltration

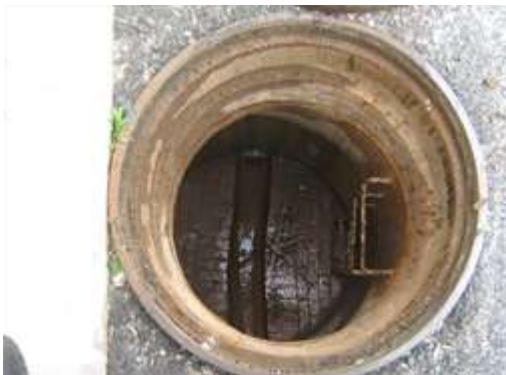
### Defect 3

**Frame** Offset: **1** (in.) Condition: ☒ Sound ☐ Cracked ☐ Leaks

frame offset

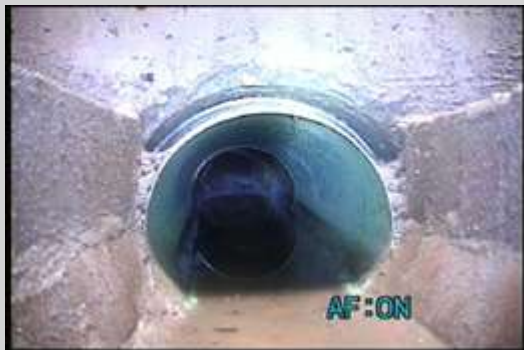
12 O'Clock Outflow

8 in. Circular Gravity Sewer  
Pipe Out @ 12 O'Clock

Pipe Height: **8.4** (in.) Rod and Bar (Angled)  
Pipe Material: **PVC** ☐ Pipe Lined  
Invert Depth: **8.24** (ft.) Flow Characteristics: **None**  
Deposits: ☒ None ☐ Mud ☐ Sludge ☐ Debris ☐ Grease  
Silt Depth: **0** (in.) Deposits Extent:  
Infiltration: **None** Pipe Seal Cond: **Sound**

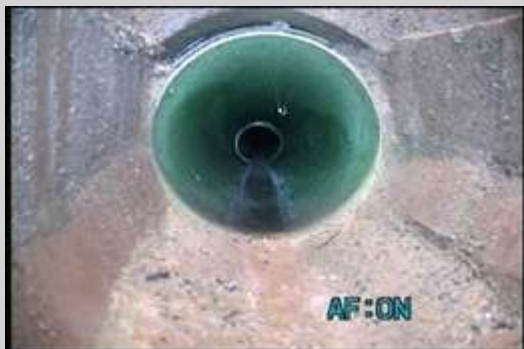
6 O'Clock Inflow

8 in. Circular Gravity Sewer  
Pipe In @ 6 O'Clock

Pipe Height: **8.4** (in.) Rod and Bar (Angled)  
Pipe Material: **PVC** ☐ Pipe Lined  
Invert Depth: **8.06** (ft.) Flow Characteristics: **None**  
Deposits: ☒ None ☐ Mud ☐ Sludge ☐ Debris ☐ Grease  
Silt Depth: **0** (in.) Deposits Extent:  
Infiltration: **None** Pipe Seal Cond: **Sound**
